# SHENANDOAH OF SARK

'Not only her beauty but even her motion under sail resonates with a deep authenticity'

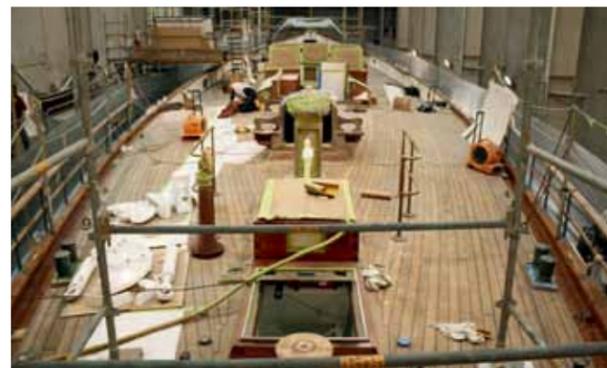
**With her bowsprit removed, *Shenandoah of Sark* is carefully moved into the Orams refit shed**

The yacht, meanwhile, had been hauled and backed into the Orams shed, just squeezing in with the bowsprit removed. The first order of business was to dismantle the crew access area to create the pre-planned enlarged aperture for removing machinery from the engine room and delivering the new Northern Lights gensets. That preparation needed a
